AMES POND DAM

MA. 01006
DIKE A, MA. 01296

PHASE I INSPECTION REPORT
NATIONAL DAM INSPECTION PROGRAM

DECEMBER 1980

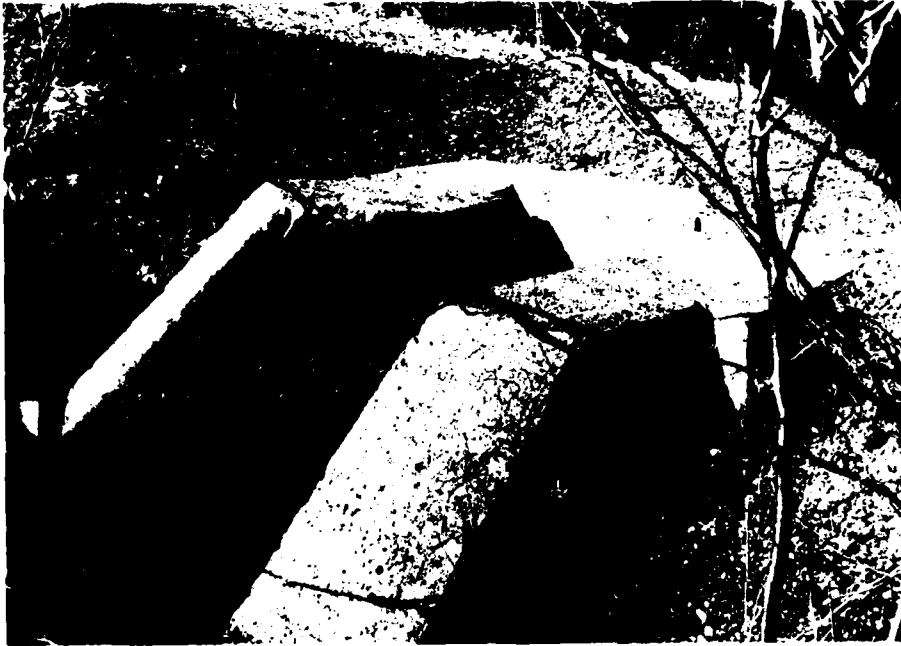
13. Extensive erosion on upstream slope of Dike A at abandoned outlet structure.

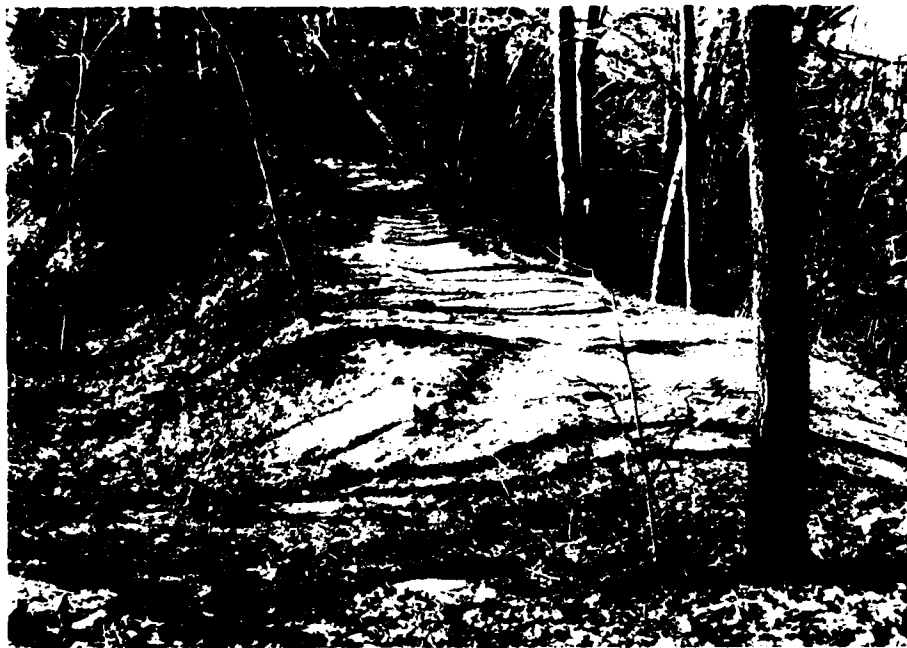
11. View along crest and downstream slope of Dike B.

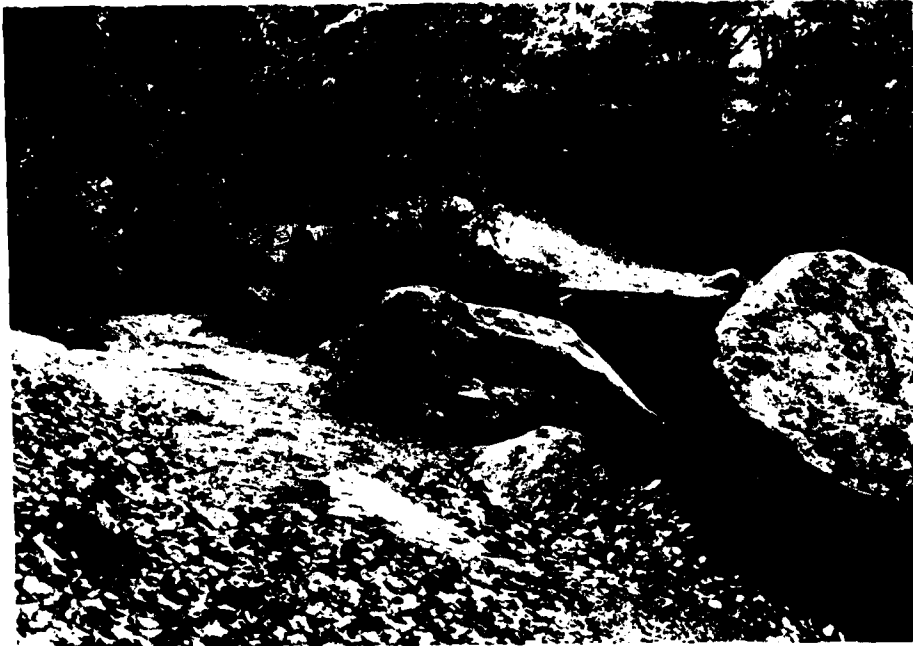
3. Boulders on upstream slope of left dam embankment.
